Component Upgrade For The Yamaha R15

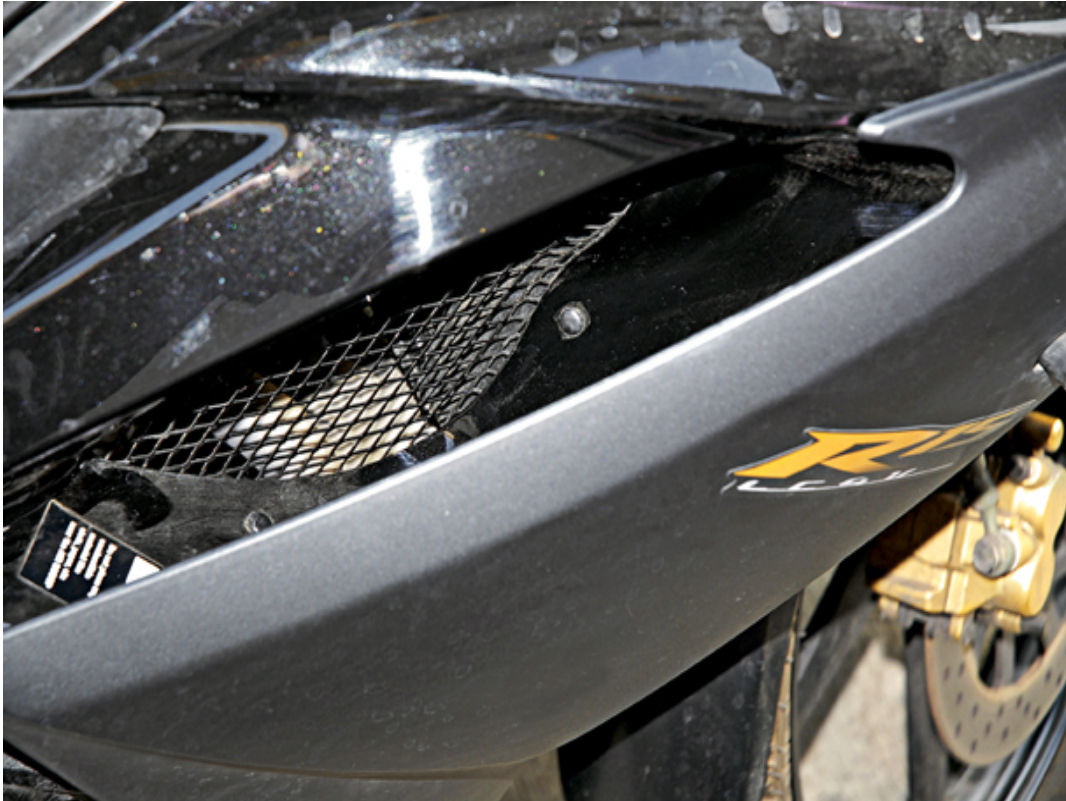
Since its launch, the Yamaha YZF-R15 has faced issues related to over heating of the engine due to misuse of the fairing panel gaps in the R15 bodywork. The most common one is the tucking in of a cleaning cloth in the gap on the right hand side of the fairing.

In a few cases, these cloth pieces have caught fire resulting in a total loss of the vehicle. To avoid such accidents and misuse on the owner's part, Yamaha is now offering a free upgrade to a new fairing panel which includes a mesh lining which avoids easy access to the engine (shown in the picture). All R15 owners can contact their nearest Yamaha dealer for this component upgrade.
